CASE STUDY

BELLINGHAM TECHNICAL COLLEGE — RETRO-COMMISSIONING IDENTIFIES INDOOR AIR QUALITY SOLUTIONS

College Services Building

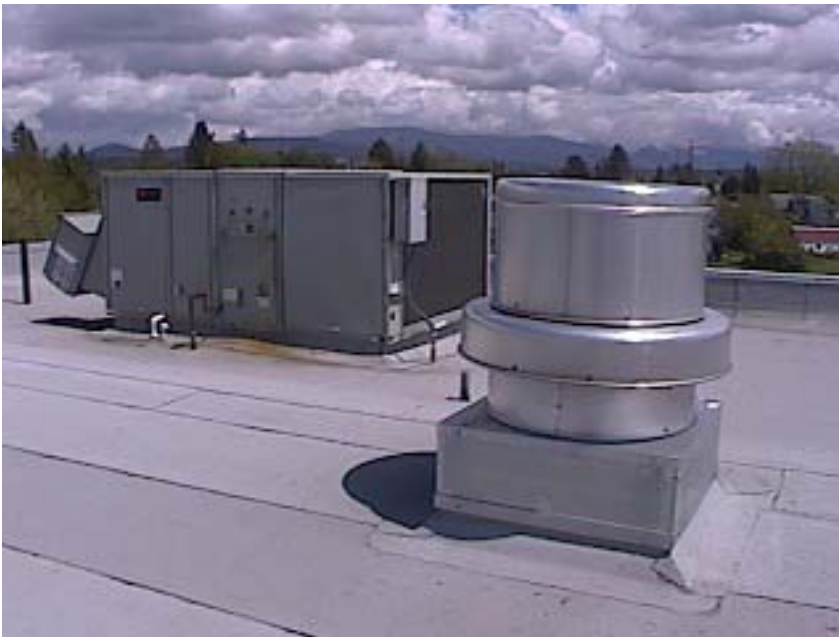
Rooftop air handling unit and exhaust fan

1. Remove restrictions to return air path.
2. Replace the by-pass dampers on roof-top air handling units (dampers had not been sized or installed correctly).
3. Install auxiliary exhaust fans with variable speed drive (existing fans were not installed correctly and contributed to building pressure problems).
4. Replace terminal units with variable air volume (VAV) units with electric reheat.
5. Install new control system.
6. Repair rooftop air handling units (RTU).
7. Repair miscellaneous issues including holes in ductwork, grilles blocked with cardboard, access issues, incorrect labeling, and missing insulation.
8. Re-balance HVAC system.
